## Brake booster rebuild notes from others

# ATE Brake Servo Rebuild

## **Breakdown of the H31 brake booster**

# Later style ATE Brake Servo

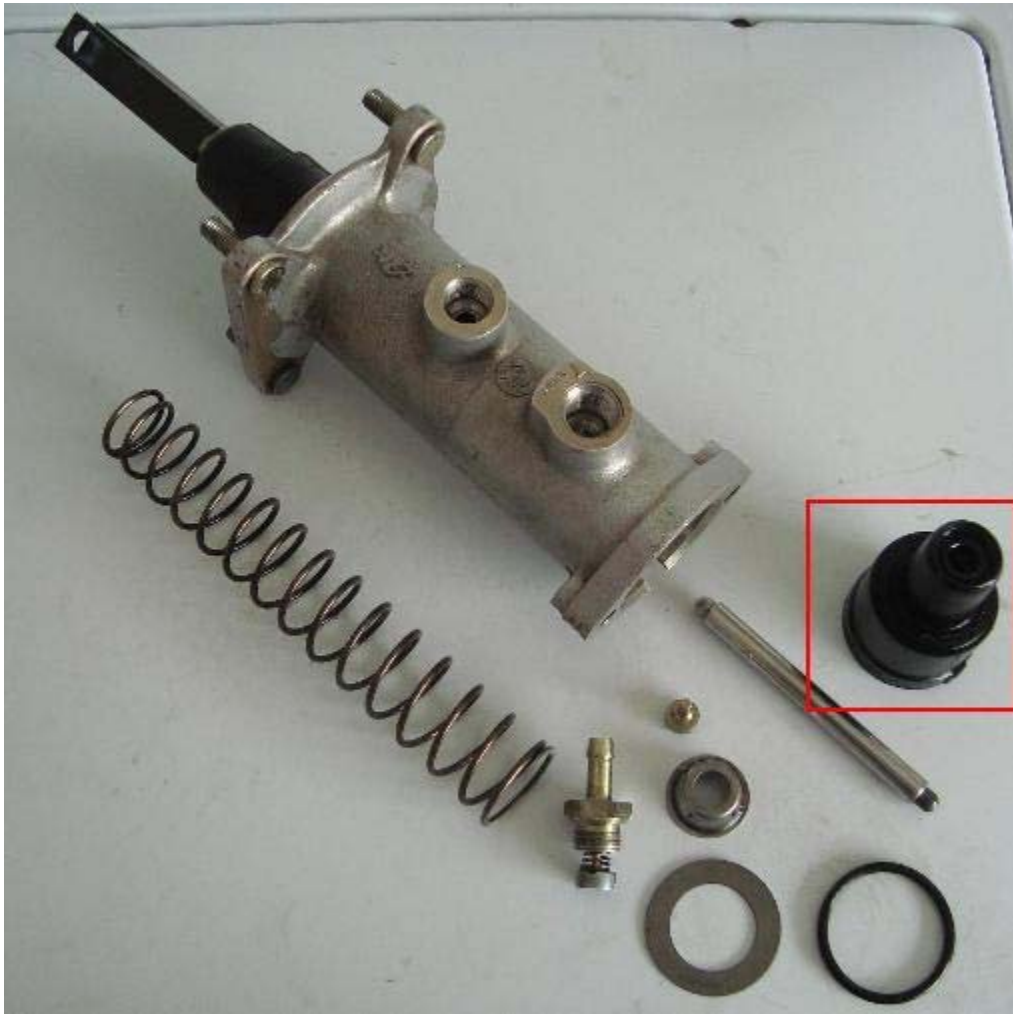
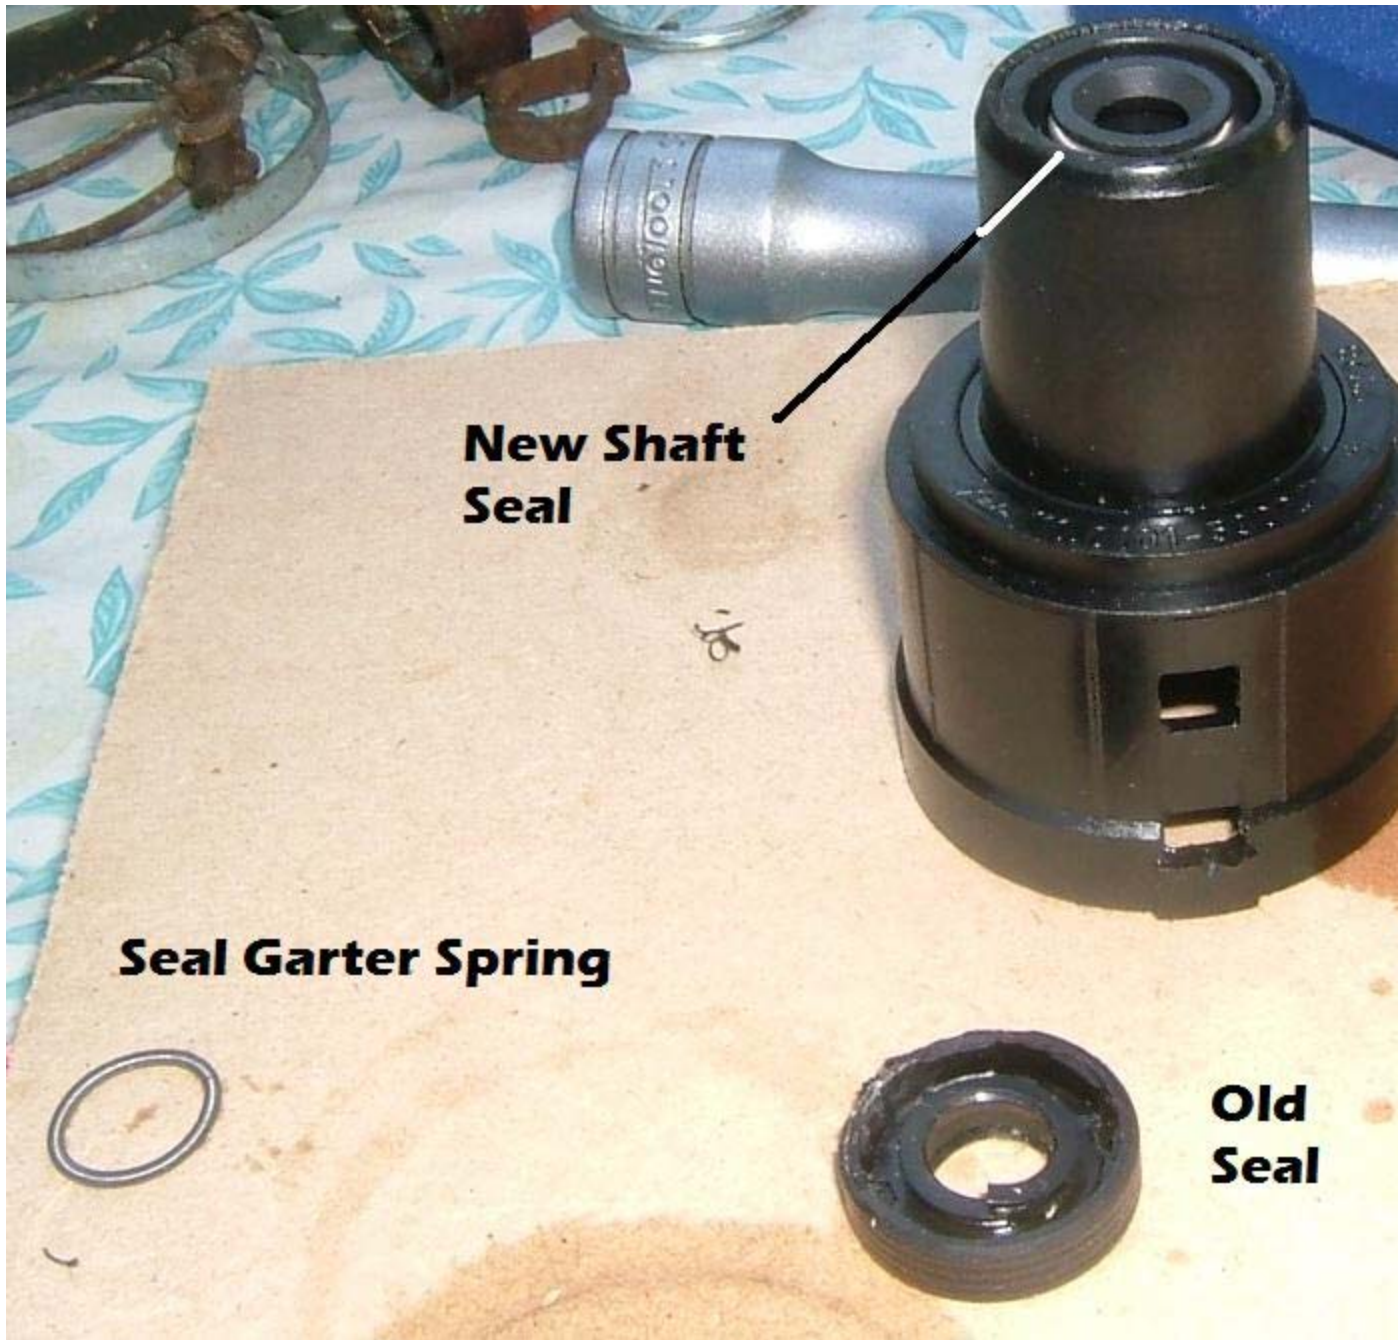
So, having figured that out, I reassembled the whole thing and pressurized. Now I'm getting a small leak, but I suspect it's from the front cup assembly's (see red below) shaft seal bushing.

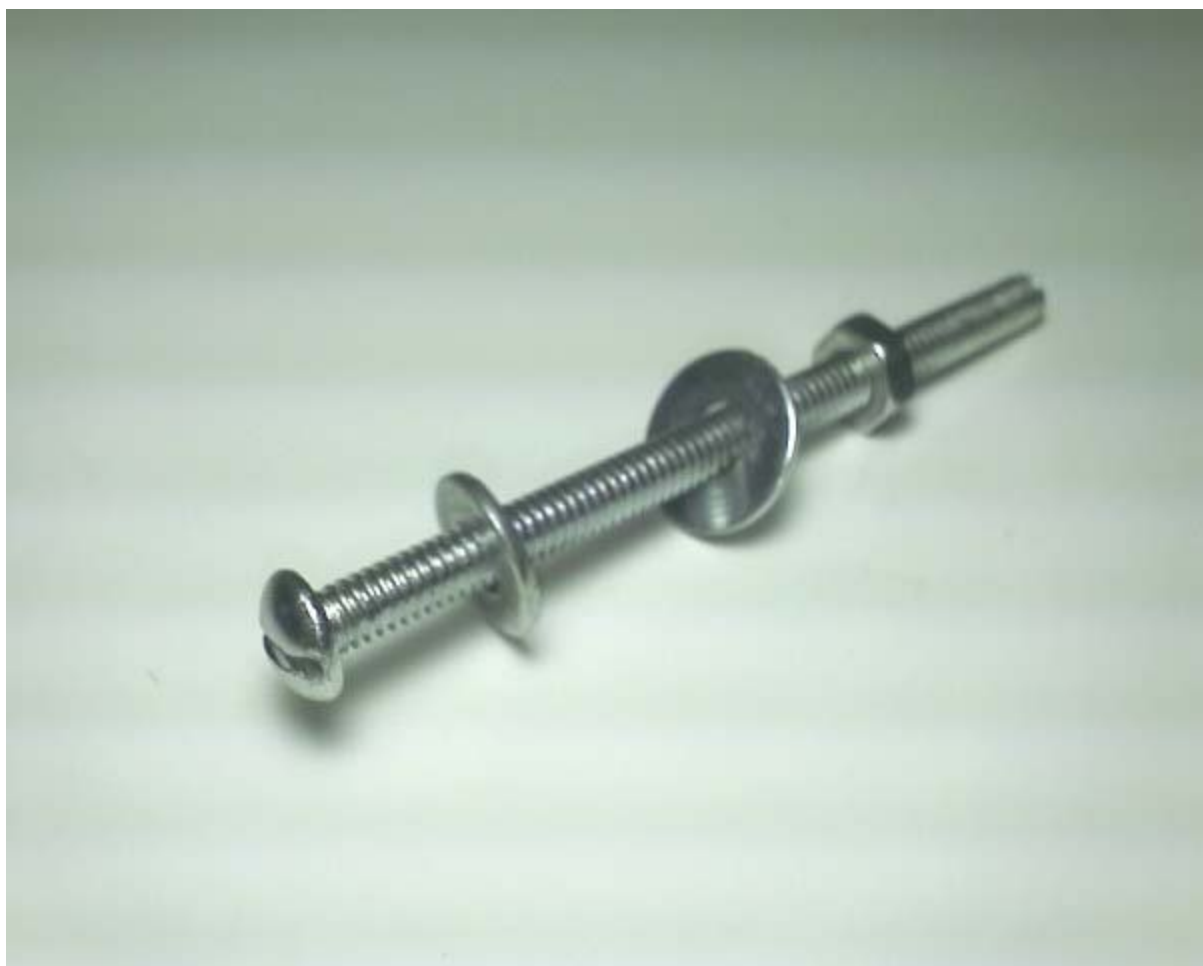
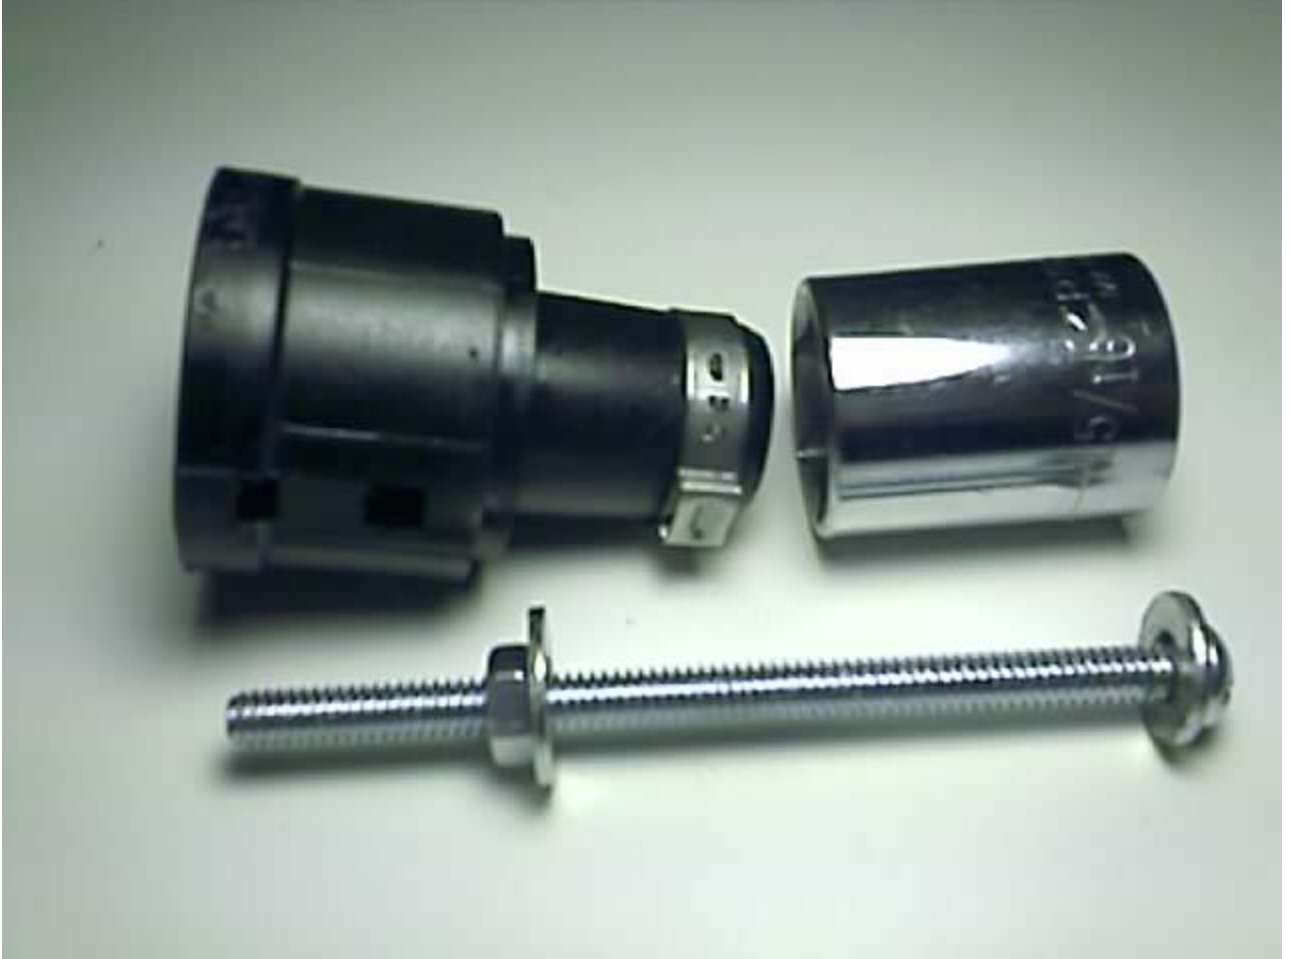
Well, just finished R&R the plunger/shaft seal. Removal was pretty easy having made a kluged-up removal mandrel consisting of a long 1/4" screw, some washers and a bolt, combined with a semi-deep socket:

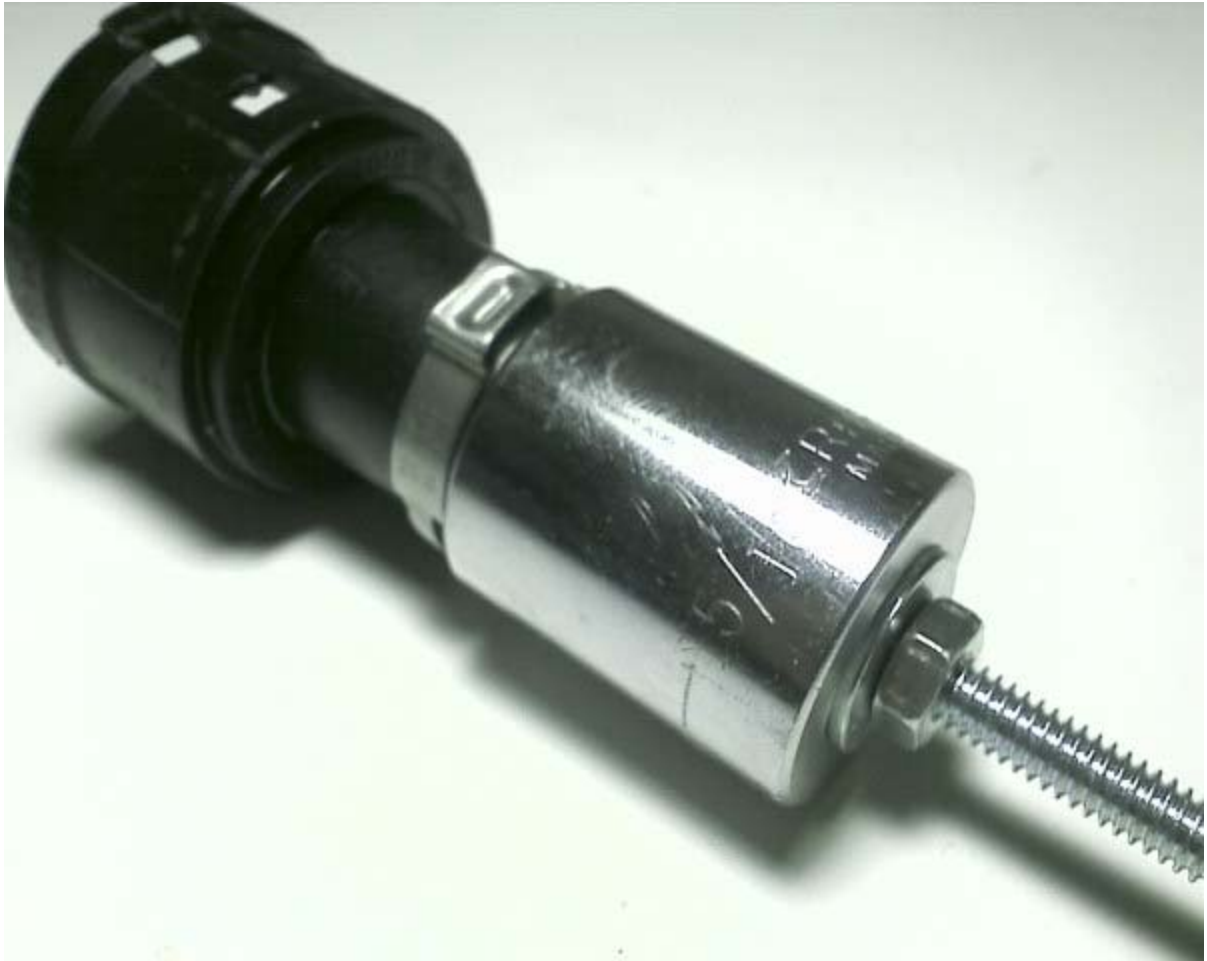
I threaded a large washer onto the "inside" facing of the seal, pulled the screw through the seal and mounted a 15/16" socket (1/2" drive) onto the "nose" of the cup to provide some area to pull the seal. Again, another washer and then finally the nut:

You might notice that clamp around the nose of the cup. I **lightly** crimped an Oetiker 22mm clamp for provide strain support for all these operations, but in reality you probably don't need one if you proceed very carefully.

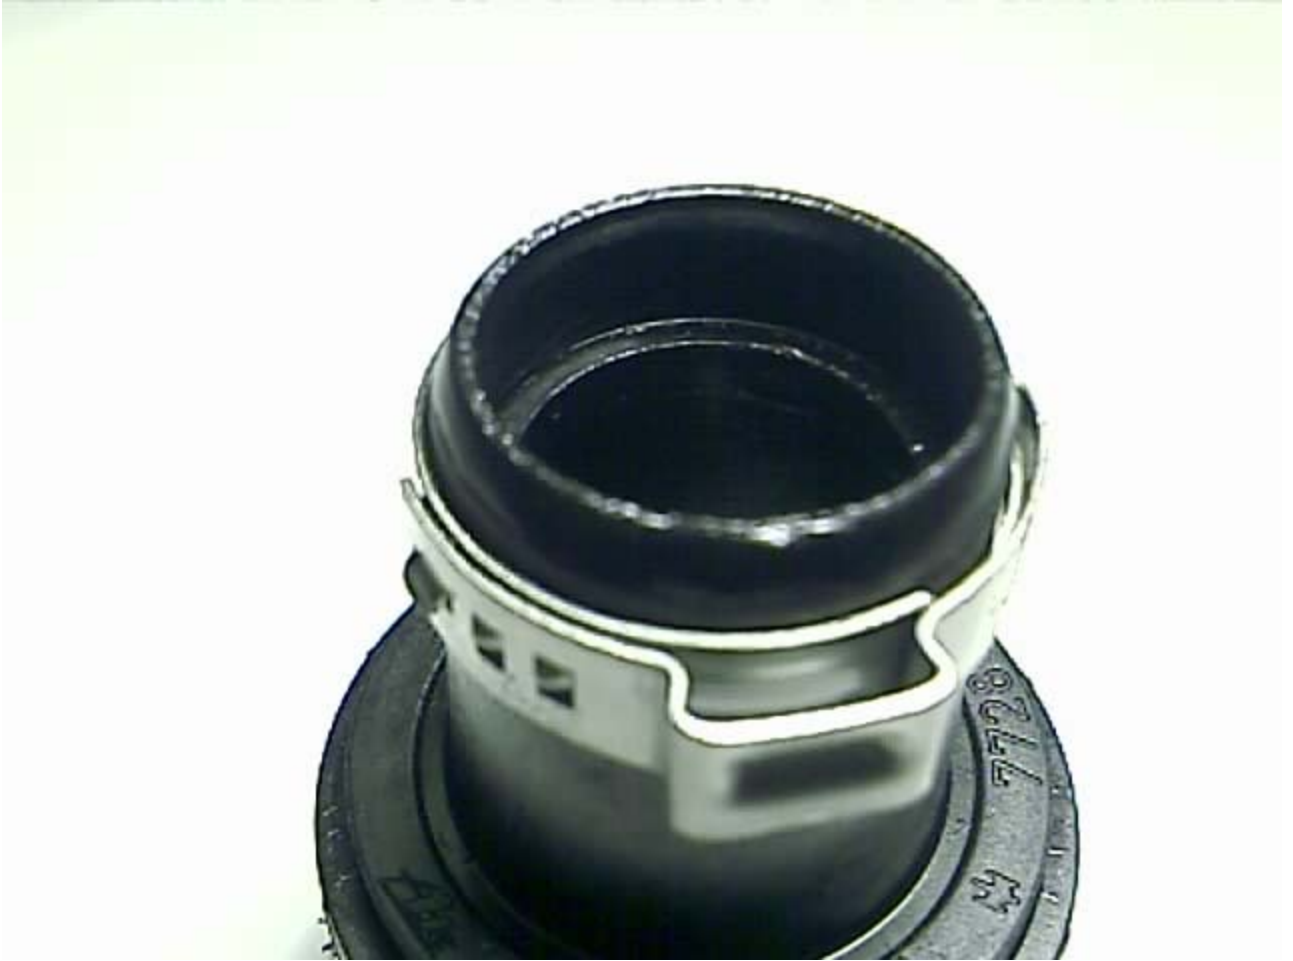
With a decent number of wrench turns, the seal is smoothly pulled from the cup nose recess. Part 1 is now complete:

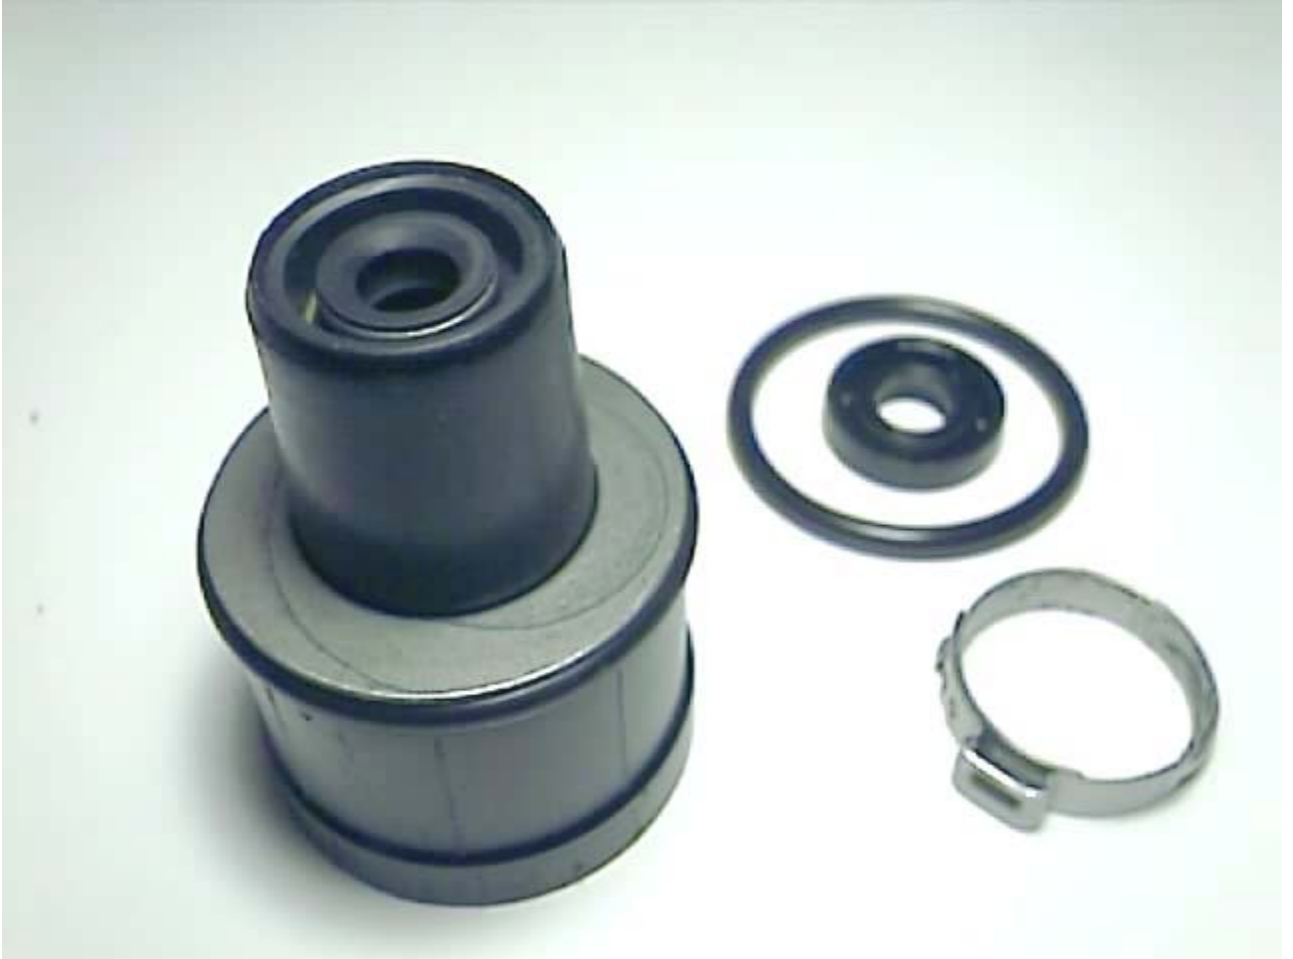
Bill recommended sanding down the lip a bit to provide some bevel to help start the new seal into the bore. Some 150 grit sandpaper did the trick. Next I placed a 32mm 1/2" drive socket into the big end of the cup. The socket protrudes from the cup and rests on the first shoulder inside the cup, and takes the compressive forces that the rather fragile lip might bear. On the seal side, I placed some flat shim steel to evenly distribute forces over the width of the seal. Next I placed the seal on the bore lip, dribbled some dish soap over the

seal, and wound up the vise while heating the neck of the cup with a hair dryer to provide some expansion (another suggestion from Bill). The seal moved smoothly into position. I had to push the seal completely home using a small socket that matched up with the O.D. of the seal. Again, a little force from the vise did the trick.

The new seal feels much, much tighter around the plunger. We'll see if it solves the problem. Stay tuned.

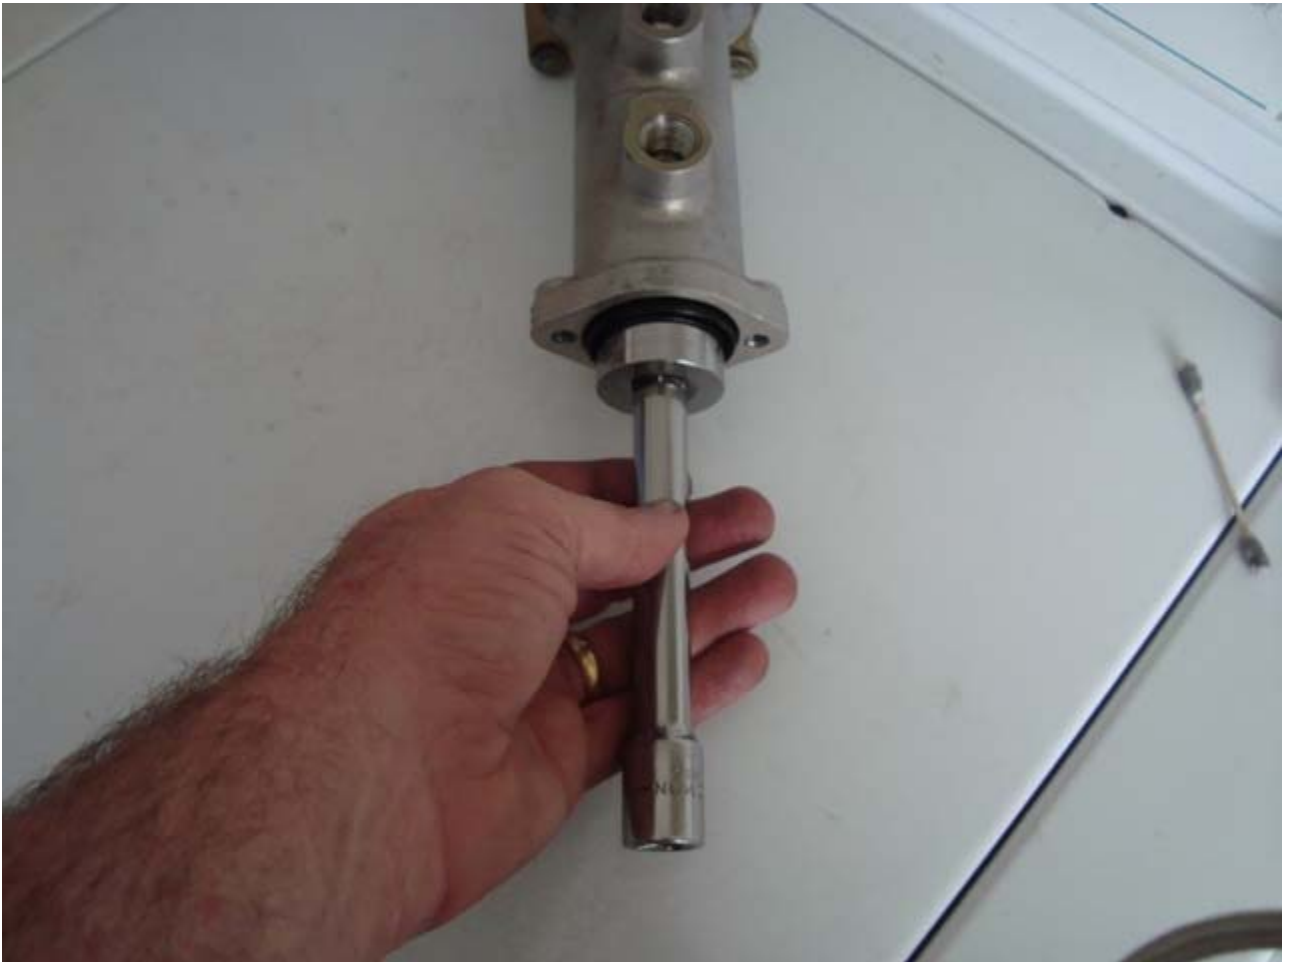
Also, here's another trick to disassemble and reassemble the cup. I took a 32 mm 1/2" drive short socket with a 6" extension and inserted into the cup prior to releasing the set screw. Makes it easy to walk/rock the always-stuck cup out the first few millimeters, and then once it starts out, to hold it against the considerable spring pressure:

It also helps installing the cup with the new O-ring. Line up the cup so the cast index tab meets up with the recess in the casting, compress the spring, and slightly rock/tip the cup back and forth to start it into the bore. That 1/2" extension gives you some mechanical advantage.

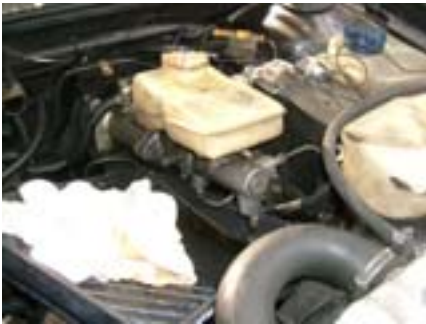
Linkage

1. Pump brake pedal until it goes hard
2. Remove spring clip from bottom of linkage pin and remove pin
3. Remove split-pin and spring
4. Syphon out brake fluid from master cylinder reservoir
5. Disconnect brake lines from master cylinder
6. Disconnect hydraulic pipes from servo
7. Remove 4 bolts holding servo in place (loose nuts on back)
8. Remove servo & master cylinder

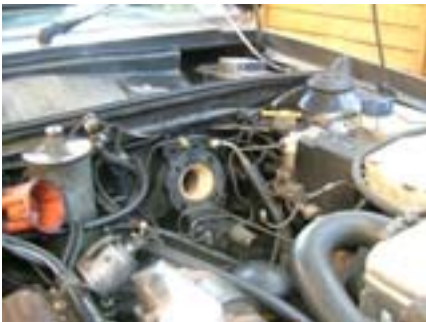
Brake pipes

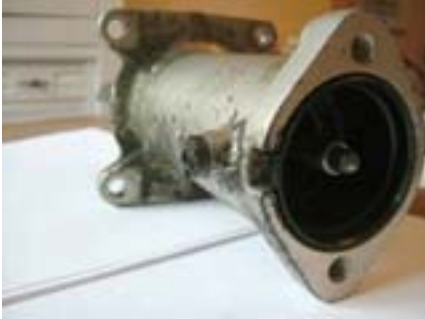
[Set screw](#)

**WARNING:** The set screw is all that holds the servo components in, there is a large spring that will try and throw the components all over the place when you remove the set screw!

1. Loosen set screw half a turn using mole grips
2. Place servo on workbench master cylinder side down, push down with considerable force, remove set screw and slowly release downward force
3. The servo components may be stuck in place by dried up hydraulic fluid, if so carefully prise out the plastic insert by placing a flat bladed screwdriver through the hole in the side of the plastic insert. At some point you'll break the resistance and if your not careful, everything will go flying. To prevent this place a pile of rags against a wall and place the servo an inch away so that the rags/wall prevent everything coming out.
4. Gently remove remaining components, a pair of long-nose pliers wrapped in rags works fairly well.

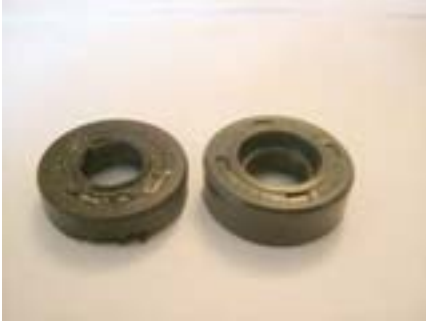
[Old/new oil seal 1](#)

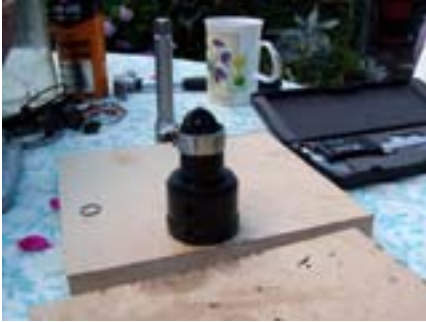
Removing old seal

1. Place a hose clamp around the neck of the plastic insert to prevent it expanding too much and shattering while removing the oil seal.
2. With a flat bladed screw driver and small hammer, repeatedly hit the back of the oil seal on the same side until it rotates out. Be gentle, it took me the best part of an hour
3. Thoroughly clean the plastic insert with a lint free cloth
4. Lubricate the new seal with fresh ATF
5. Press new seal in with a vise. I found it was necessary to start the seal off at a very slight angle to get it started and then straighten it up by pushing/pulling on the block of wood in the vise at the seal end

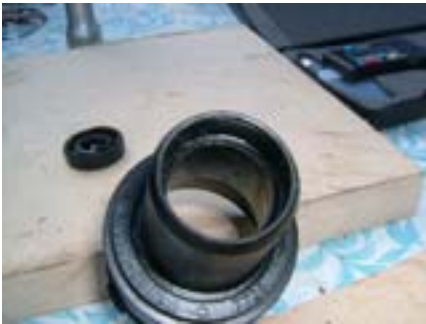
Seal removed

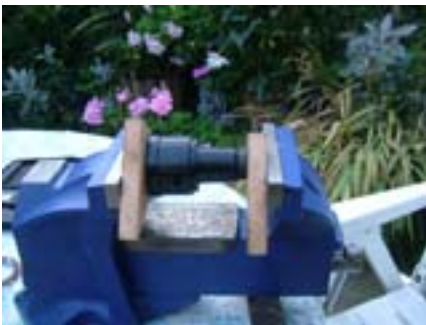
Pressing in new seal

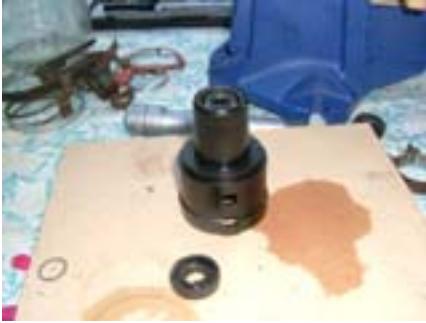
Seal replaced

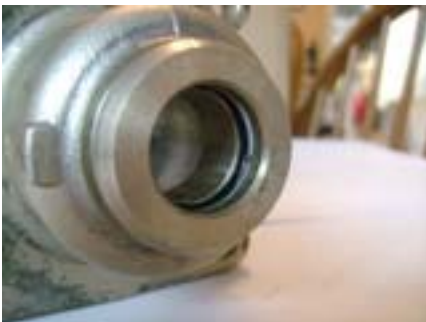
Input shaft o-ring

1. Remove the o-rings with the proper tool or a small flat-bladed screwdriver wrapped with several layers of selotape
2. Lubricate new o-rings with fresh ATF and install

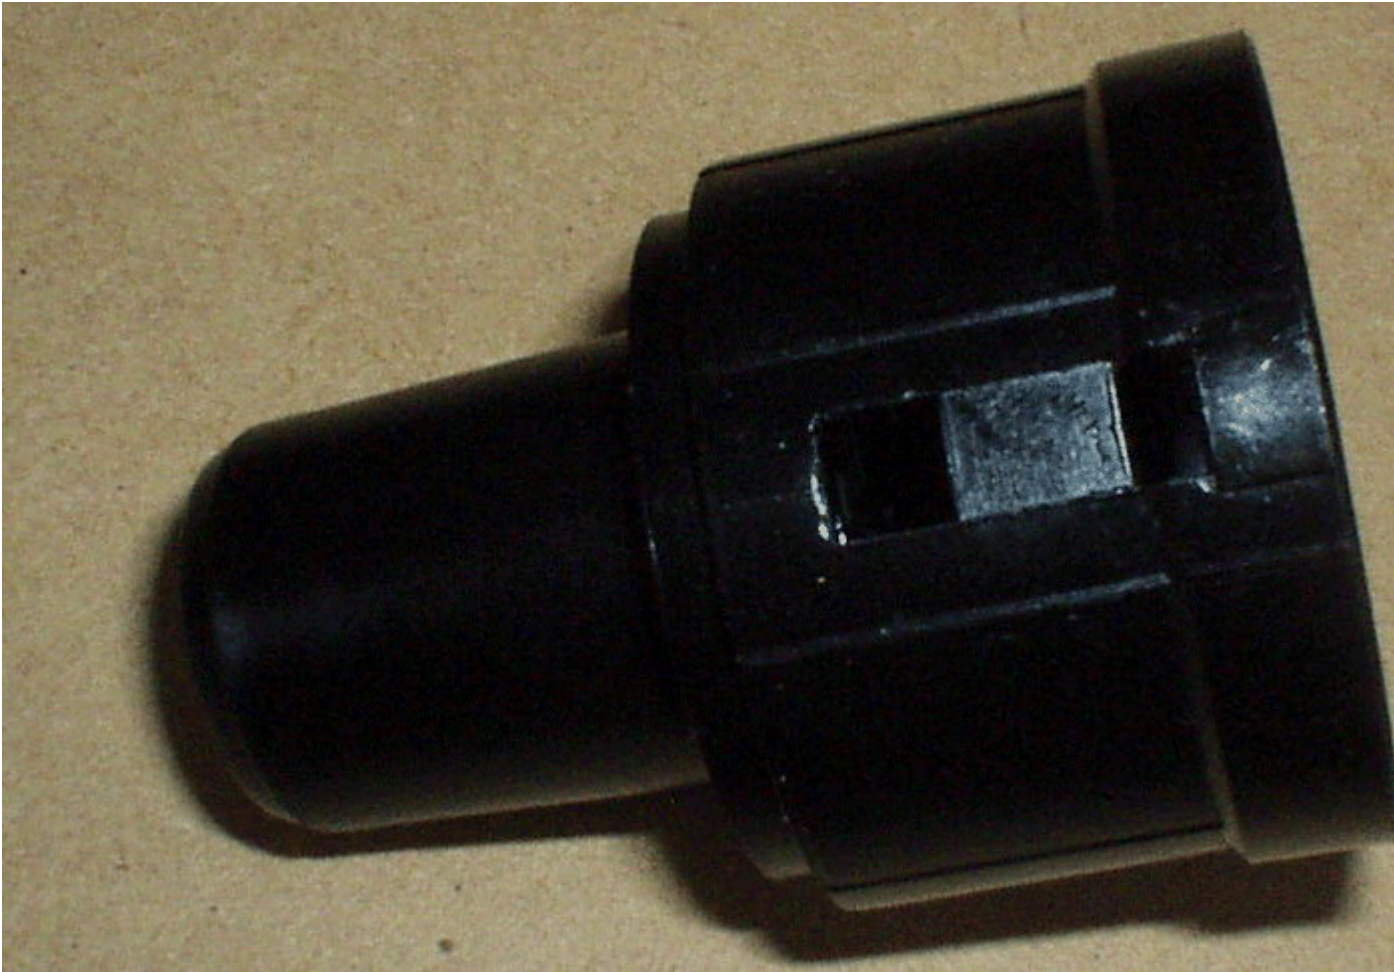
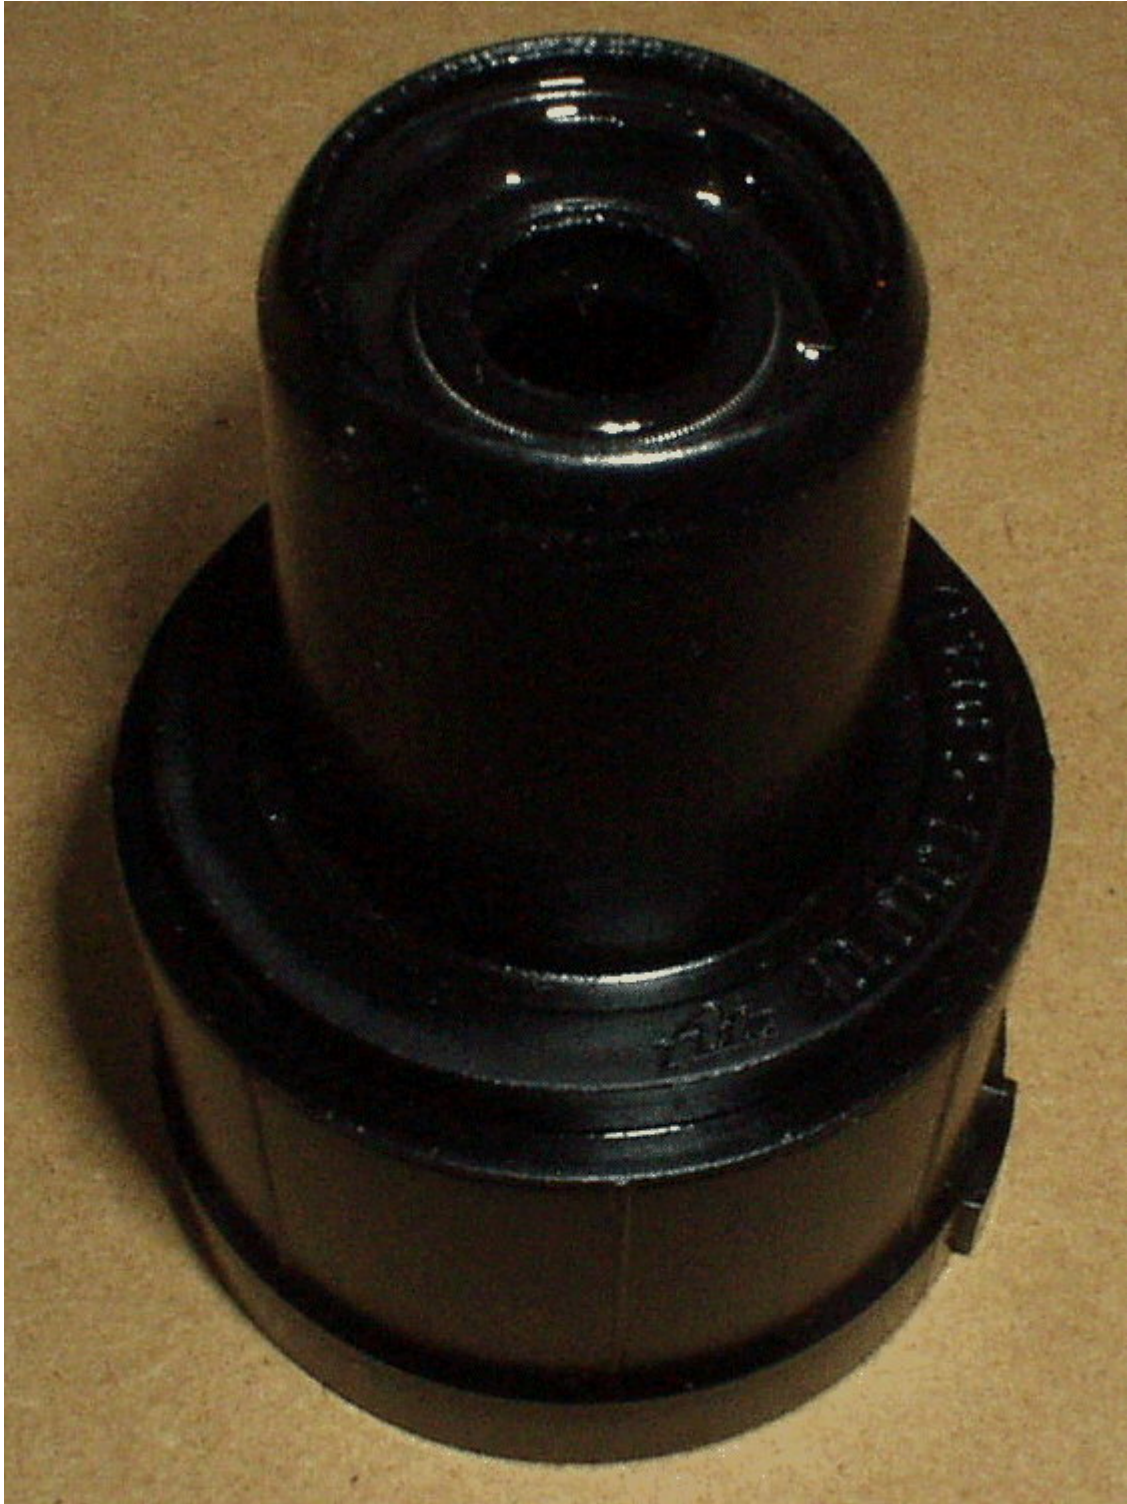
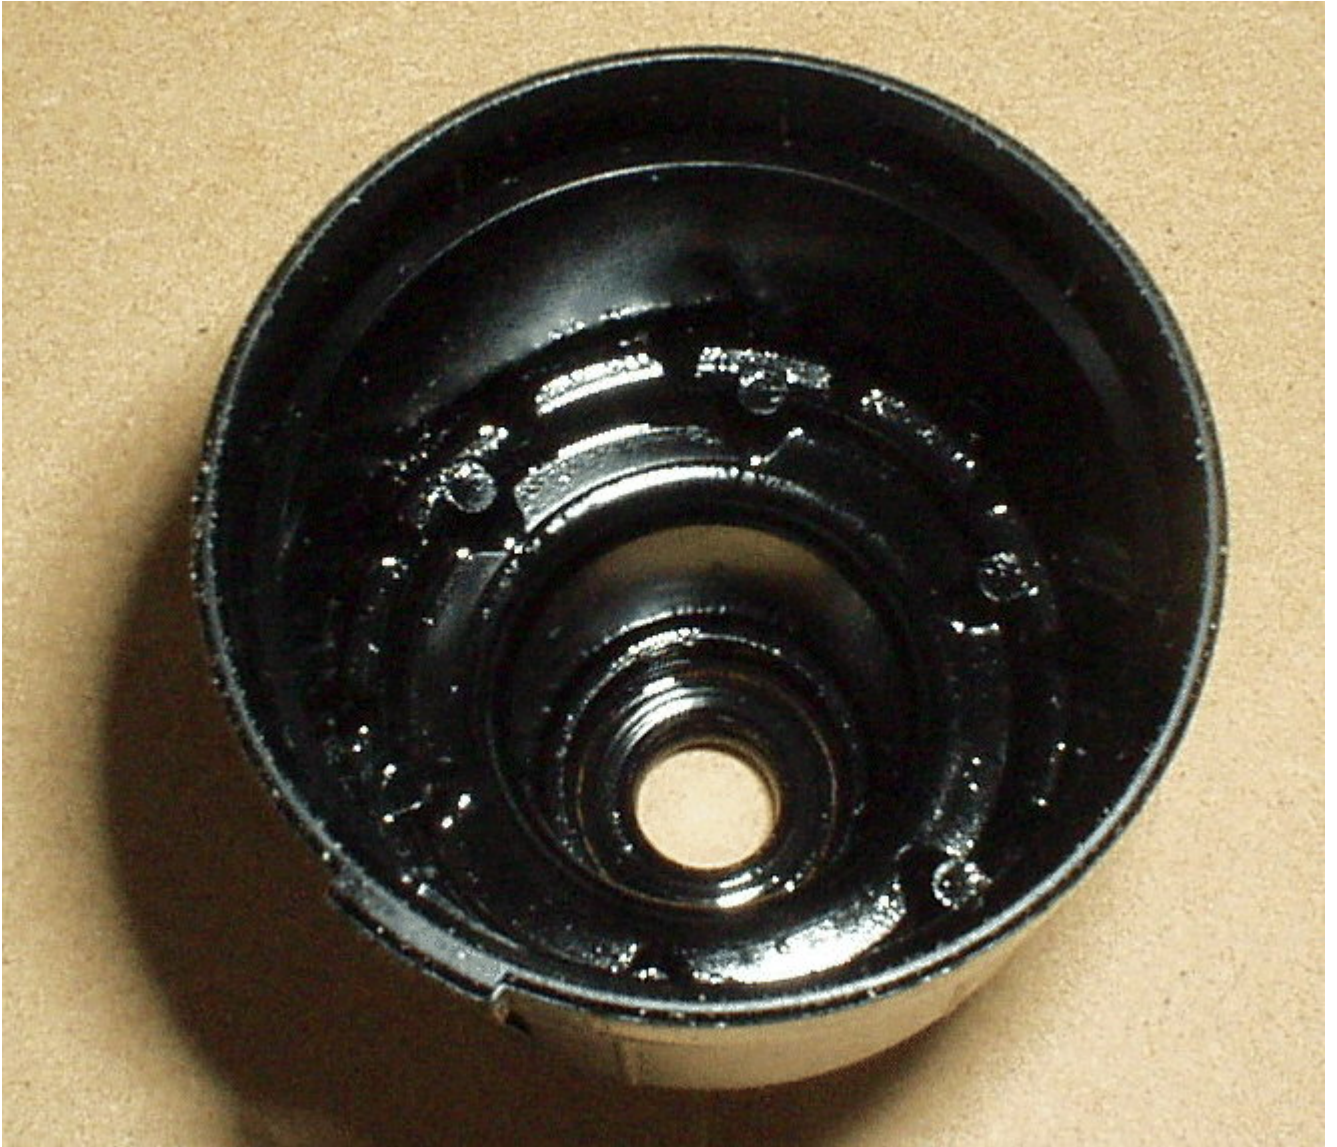
The main culprit for rebuilding would be the endcap K - here's some close-ups, the seal seems to be a normal kind of seal, but possibly glued into the plastic endcap itself:

Remember too that the seal for the outer edge of the endcap (to the bore) is via o-ring J which is compressed between the step on the endcap inside end and the spring-seat washer I.

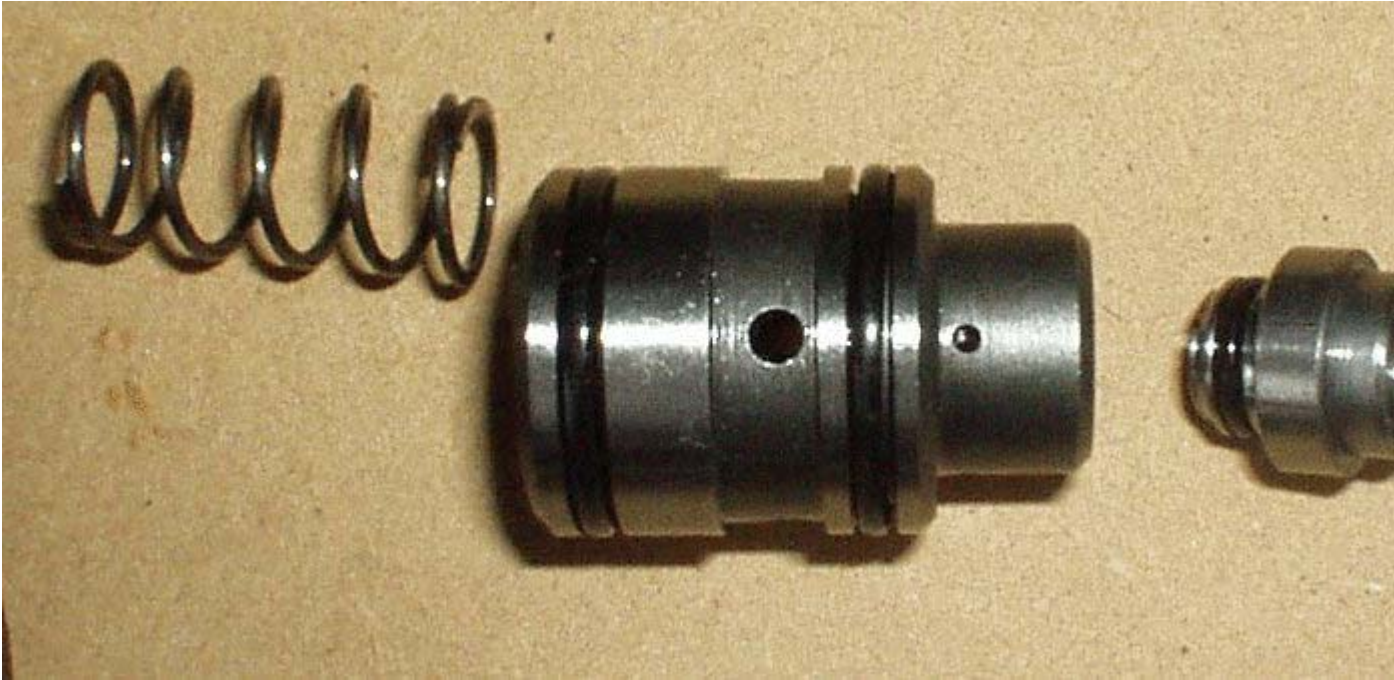
All the other items do have varying seals, but all of the common o-ring types - since we're using common ATF I don't think they're any special material, probably just normal neoprene. The control piston D has 2 on it; it's usually stuck inside the servo piston B, with the pushrod seat E stuck into its end (E has one o-ring on that "stuck" end). Wiggle the end of the piston, and spring C will push the lot out.

Here's these parts in close-up:

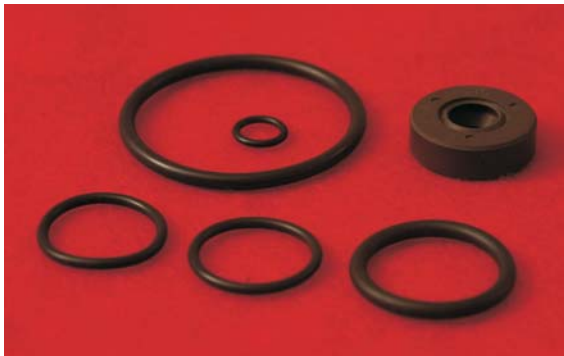
These are the new parts, replace them after a thorough cleaning of the components with a lint-free rag

Coat the new seal and o-rings with fresh hydraulic fluid as you install them.
